# Weatherizing Town Buildings

What Local Officials and Energy Committees Need to Know

Windham Regional Commission | 2012

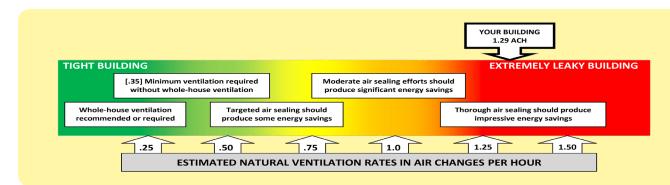
About half of all heat loss happens from air flow. This air leakage is well beyond what the occupants or building require for health. The places that get air sealed are underneath the insulation, so the air sealing needs to happen before additional insulation. Some insulation materials, such as spray foam, air seal and insulate at the same time. Air sealing is the process of closing up air leaks in the building's envelope. Typical air-sealing components include sealing around vertical shafts, such as chimneys, sealing around windows and door casings, installing weather-stripping around exterior doors, and sealing utility penetrations through floors and into attics, such as wire and plumbing penetrations. Typical air sealing materials includes rope caulk and/or spray foam. A picture of a spray foam application that was recommended for the Weston Town Garage is shown above on the left. Another way of understanding the benefits of air sealing is through determining your buildings ACH, or "Air Changes per Hour." The graphic below shows a range of ACH values and their associated meanings. This particular graphic came from the Grafton Town Hall audit report, and demonstrates just how leaky this old building was prior to its weatherization improvements.

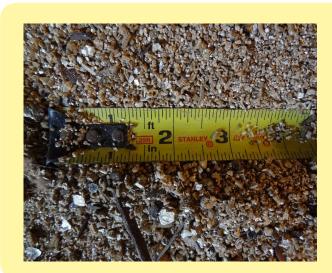
The issue: Vermiculite is "a naturally occurring mineral composed of shiny flakes, resembling mica. When heated to a high temperature, flakes of vermiculite expand as much as 8-30 times their original size. The expanded vermiculite is a light-weight, fire-resistant, and odorless material and has been used in numerous products, including insulation for attics and walls." It was used commonly as an affordable insulation material across the country, and is still in use today. However, some vermiculite is known to be contaminated with asbestos. In fact, at one point over 70% of vermiculite mined came from Libby, Montana, which had been contaminated

with asbestos. As a result, the EPA recommends "you should assume that vermiculite insulation is from Libby and treat the material as if it contained asbestos by not disturbing it or by using a trained professional if it needs to be removed. While you can hire a trained professional to test your attic for asbestos, this may be expensive and, depending on the methods used, might give you erroneous results. We do not recommend that you open your walls to check for vermiculite." The State of Vermont supports this recommendation and goes further to recommend that all vermiculite insulation be approached as if it contains asbestos and be handled accordingly.
